Inspection reference: BP15070215

Confidential Inspection Report **61 Hyde Avenue, Glenhaven**

July 2, 2015

VISUAL BUILDING AND TIMBER PEST INSPECTION REPORT

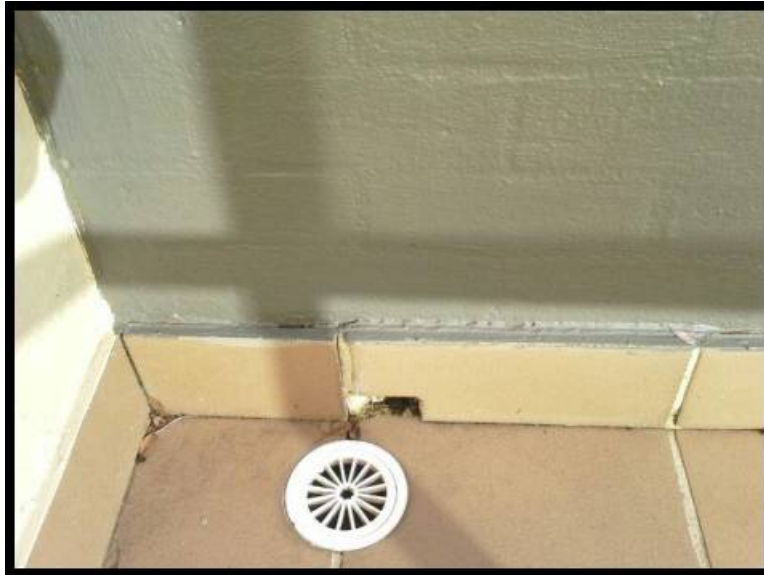
Construction & Condition: Constructed from concrete or masonry. The general condition of this structure is fair. This external floor is located above an internal area and any waterproofing failure will allow water to enter below. Recommend the area be closely monitored for water entry. If this occurs additional waterproofing will be required.

Defects Or Maintenance Items: Cracked and drummy floor tiles are present and require repair or replacement.

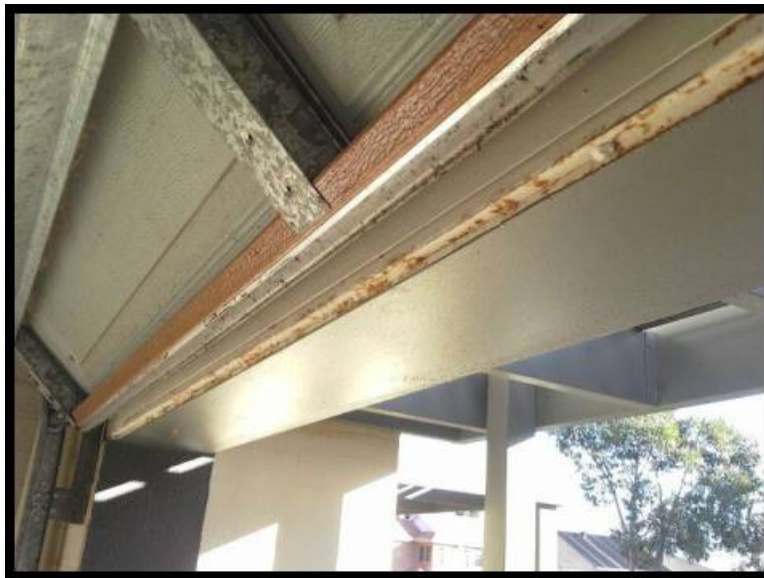
Accommodation Type: Garage.
Location: Under the main building.
General Condition: The structure is generally in fair condition.
Lintels - Type & Condition: Lintel type/s noted: Mild steel. Rust is evident to some steel lintels. Rusted areas should be treated to prevent further deterioration.

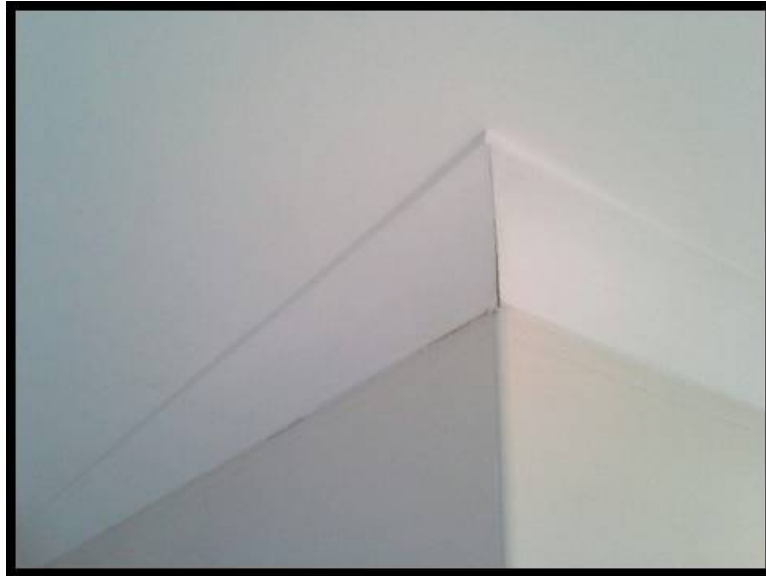
Isolated areas throughout. Ensuite.

The condition of the ceilings is generally fair. Cracking is present to cornices and these areas will require maintenance and or repair.

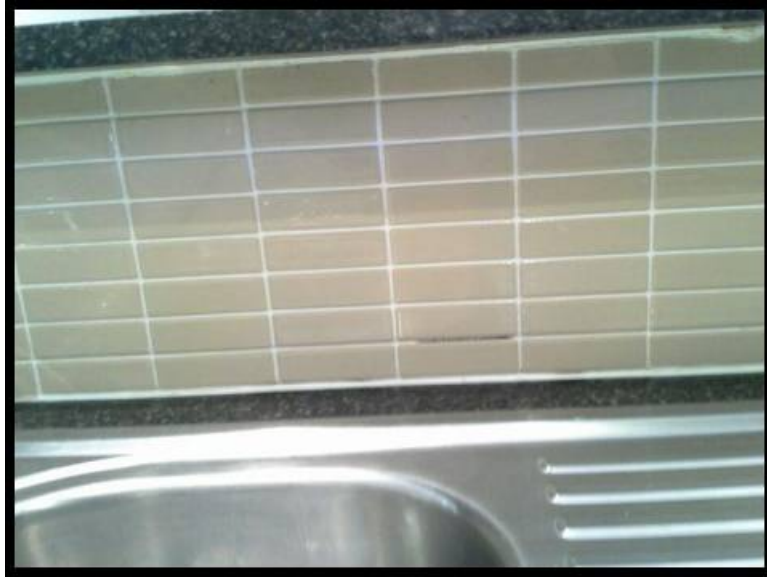
The condition of the tiles is generally fair. Grouting requires completing to the tiled areas.

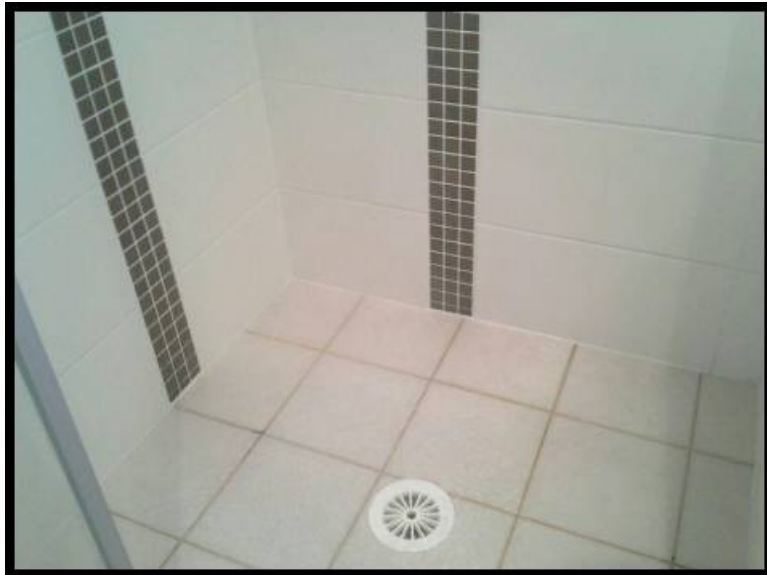
The shower recess was tested and there was no visible water penetration to surrounding areas. **IMPORTANT NOTE:** This test may not reveal water leaks until the shower is put into constant use and surrounding areas monitored over a period of time. Silicone sealant has been applied to the interface of the floor and walls in the shower recess in an apparent attempt to prevent water penetration to surrounding areas. This method of repair can only be considered to be temporary. Further waterproofing may be necessary.

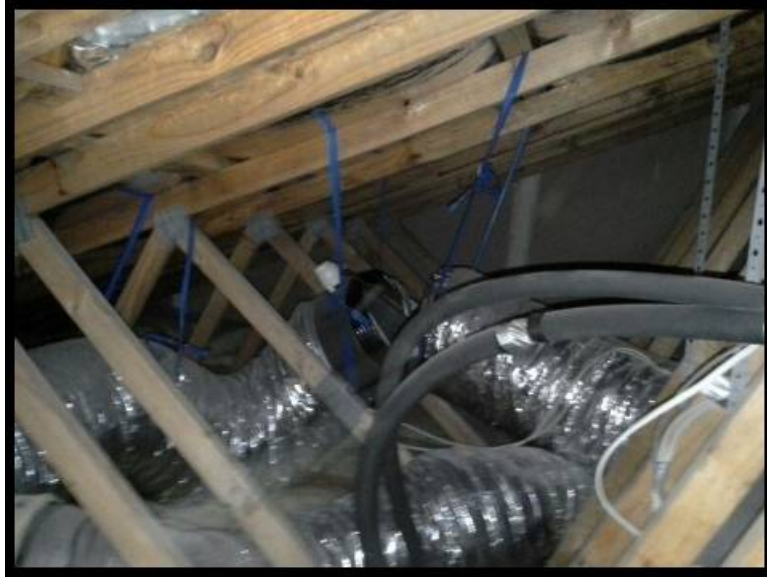
Restrictions: Sarking paper and insulation is present in the roof cavity. This restricted inspection to some roofing timbers. Removal of insulation is not within the scope of a standard visual building inspection report. Ducting associated with air-conditioning or heating restricted inspection. Inspection was restricted above the following locations and or areas: All internal areas.

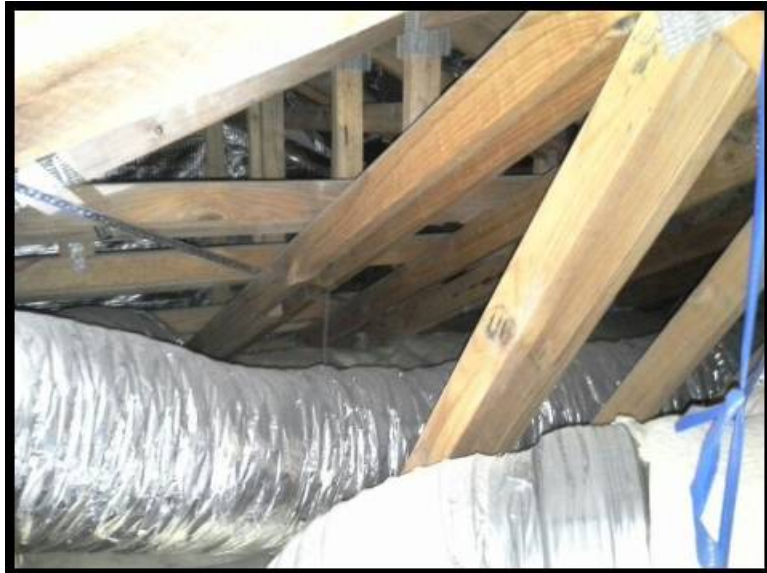
A section of the roof is of skillion type construction and there is no accessible cavity for inspection. Inspection over the eaves and low areas to the perimeter of the building was restricted due to the low pitch and method of construction allowing only a limited visual inspection from a distance. Items such as top plates and ceiling and roof framing in these areas was not able to be fully inspected. The roof is of trussed style construction and due to the nature of this construction inspection within the roof cavity was limited in some areas.

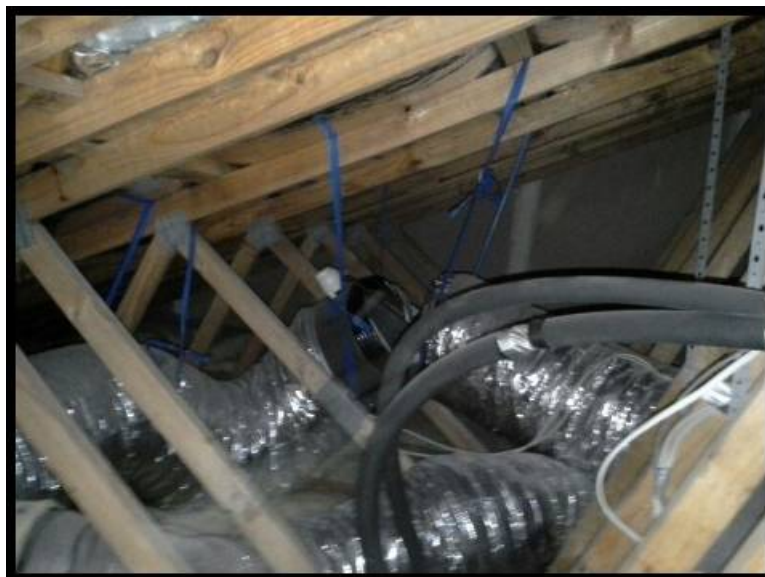
Sarking paper and insulation is present in the roof cavity. This restricted inspection to some roofing timbers. Removal of insulation is not within the scope of a standard visual building inspection report. Ducting associated with air-conditioning or heating restricted inspection. Inspection was restricted above the following locations and or areas: All internal areas.

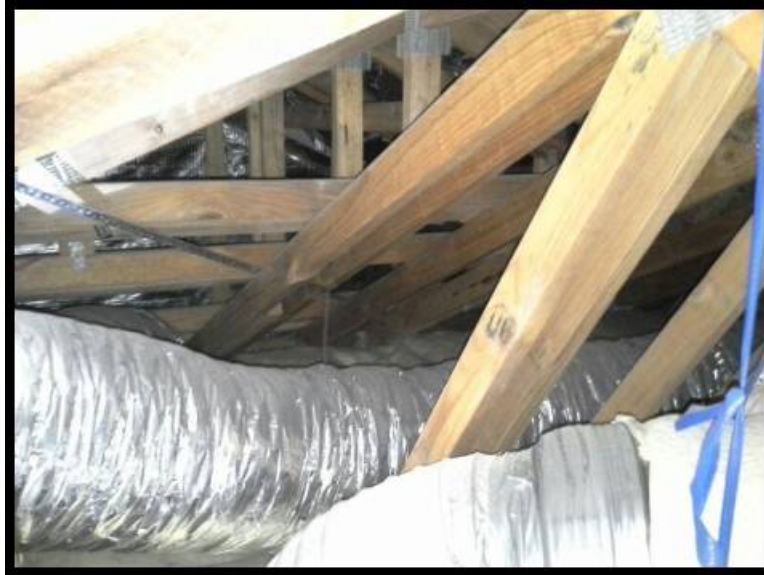
A section of the roof is of skillion type construction and there is no accessible cavity for

inspection. Inspection over the eaves and low areas to the perimeter of the building was restricted due to the low pitch and method of construction allowing only a limited visual inspection from a distance. Items such as top plates and ceiling and roof framing in these areas was not able to be fully inspected. The roof is of trussed style construction and due to the nature of this construction inspection within the roof cavity was limited in some areas.
