Inspection reference: Sample Building Compact Report

**Confidential Inspection Report**  
**2 Purchase Road**  
**Brisbane OLD 7000**

## VISUAL BUILDING INSPECTION REPORT

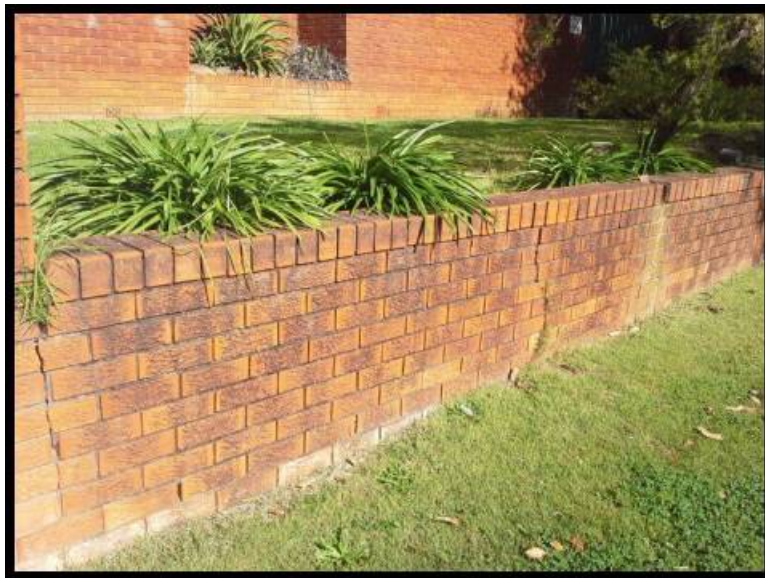
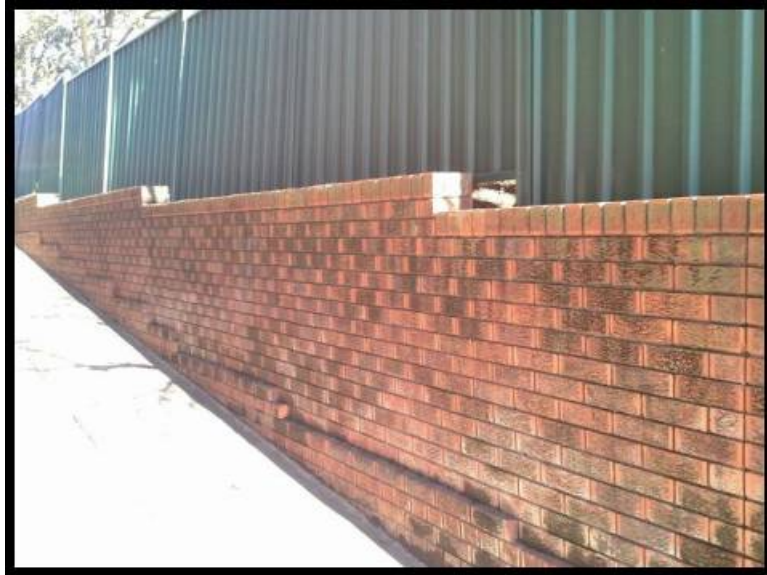
Western elevation. Front elevation.

The masonry retaining walls are in poor condition and should be repaired or replaced. The retaining wall appears to be under designed. This is not a qualified engineer's opinion and we recommend that you seek advice from Structural or Geotechnical Engineer.

The masonry retaining wall is leaning and should be monitored for additional movement. A suitably qualified Structural or Geotechnical Engineer should investigate condition of the retaining wall.

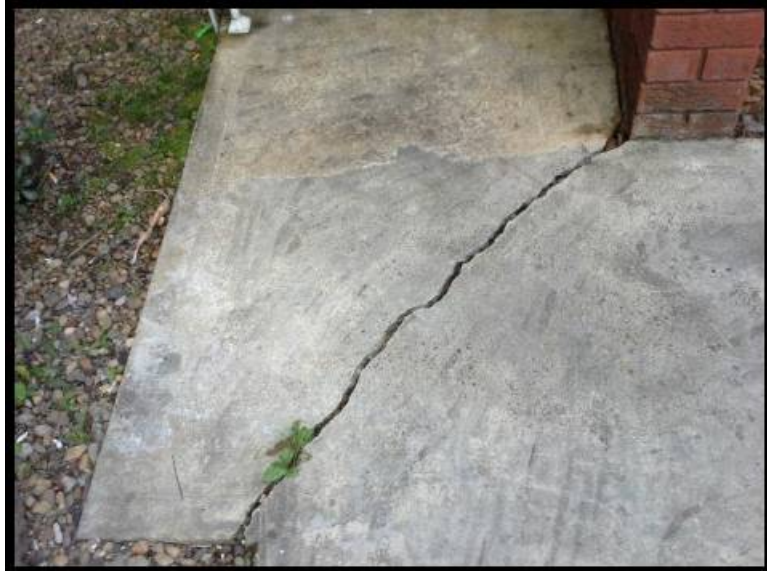
The paths have some visible cracking and damaged areas require repair and or replacement.

The paths have subsided in areas and will require repair and or relaying.

*Structural Defect Cracking:* Located: Pathways Width: 10mm Length: Various.

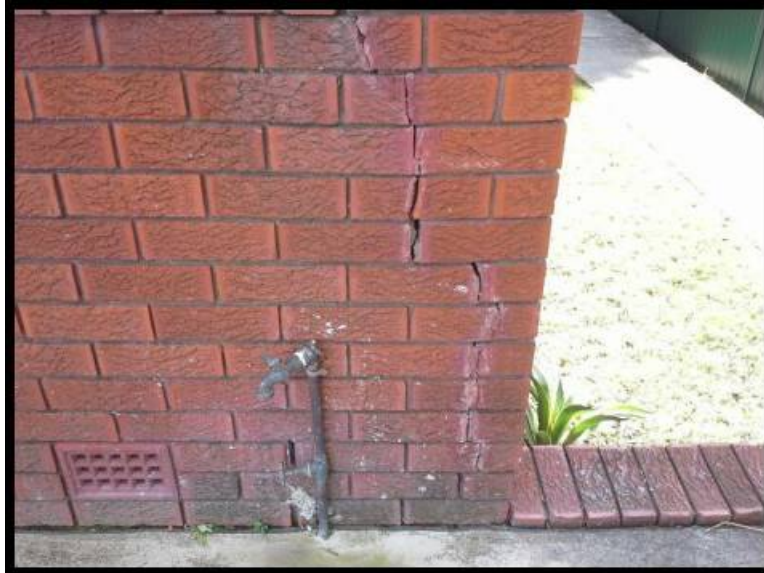
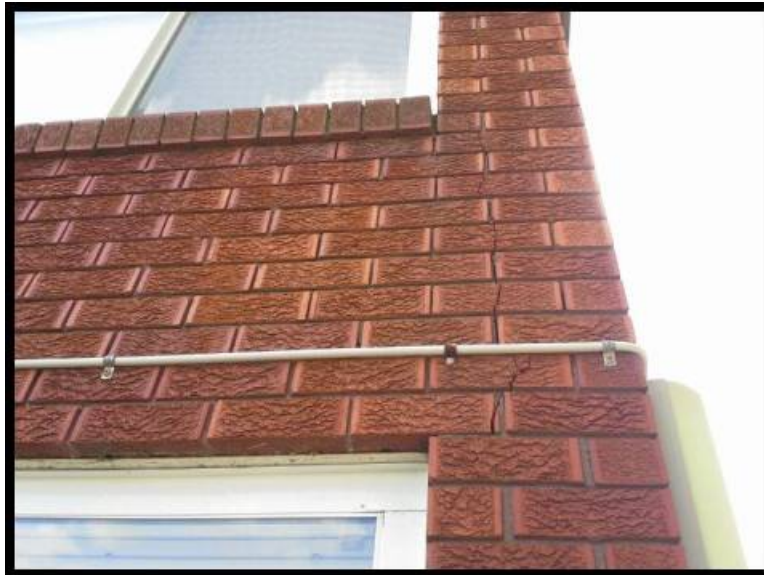
Western elevation. Rear elevation.

Cracks are evident to masonry. Visible cracking appears major and a Structural Engineers opinion should be sought. Please refer to section of this report - CRACKING OF BUILDING ELEMENTS for additional details.

Cracks are evident to brickwork. Visible cracking appears major as they are in a structural component of the building. Cracking appears to be brick growth and is common in brick buildings that have long runs of brick walls without control joints. A Structural Engineers opinion should be sought on how to repair these damaged areas. Please refer to section of this report - CRACKING OF BUILDING ELEMENTS for additional details.

The building is constructed on a combination of strip footings, piers and concrete slab. Structural cracking to external walls is evidence of subsidence to the footings. This defect should be referred to a Structural or Geotechnical Engineer for further evaluation.

*Structural Defect Cracking:* Located: Various South elevation West elevation Width: 1-3mm 5mm Length: Various.

Due to the unpredictable nature of cracking in building elements it is not possible for the inspector to determine past or future occurrences that have or will impact cracking in this building. Because of these unknowns and the possibility of concealed defects related to cracking in building elements we recommend an engineer be consulted prior to acceptance or purchase this building.

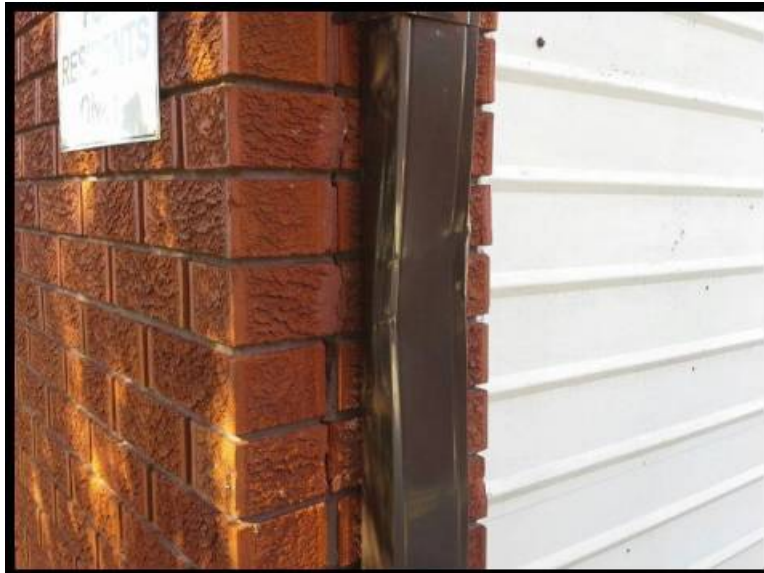
Due to access limitations the guttering and associated areas were not inspected. Defects may be present and not detected. Downpipes are damaged or rusting and should be repaired or replaced as necessary. Downpipes appear to be connected to the stormwater dispersal system, however, correct connection can only be confirmed with a smoke test.

Estimated cost from: \$1200.

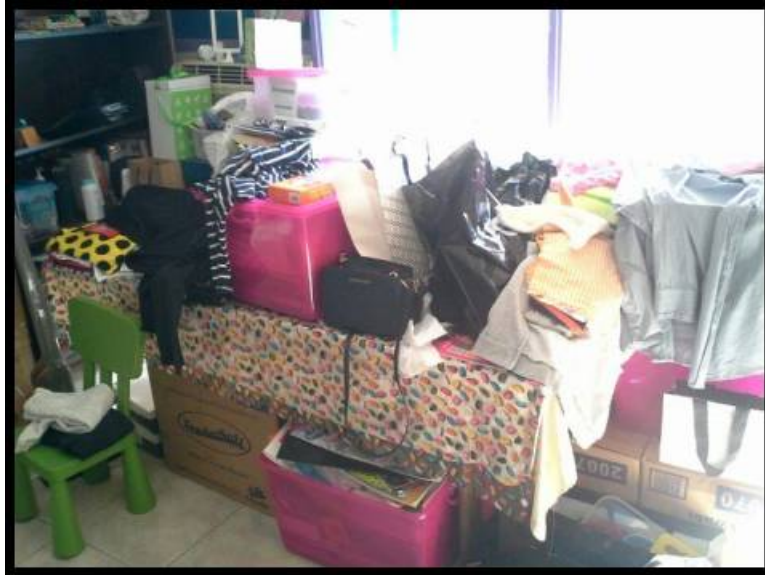
A significant amount of stored goods were present to the area(s) listed below which restricted the inspection. Stored items should be removed to allow a more complete inspection to be carried out. Access was limited in the following locations and or areas: All internal areas.

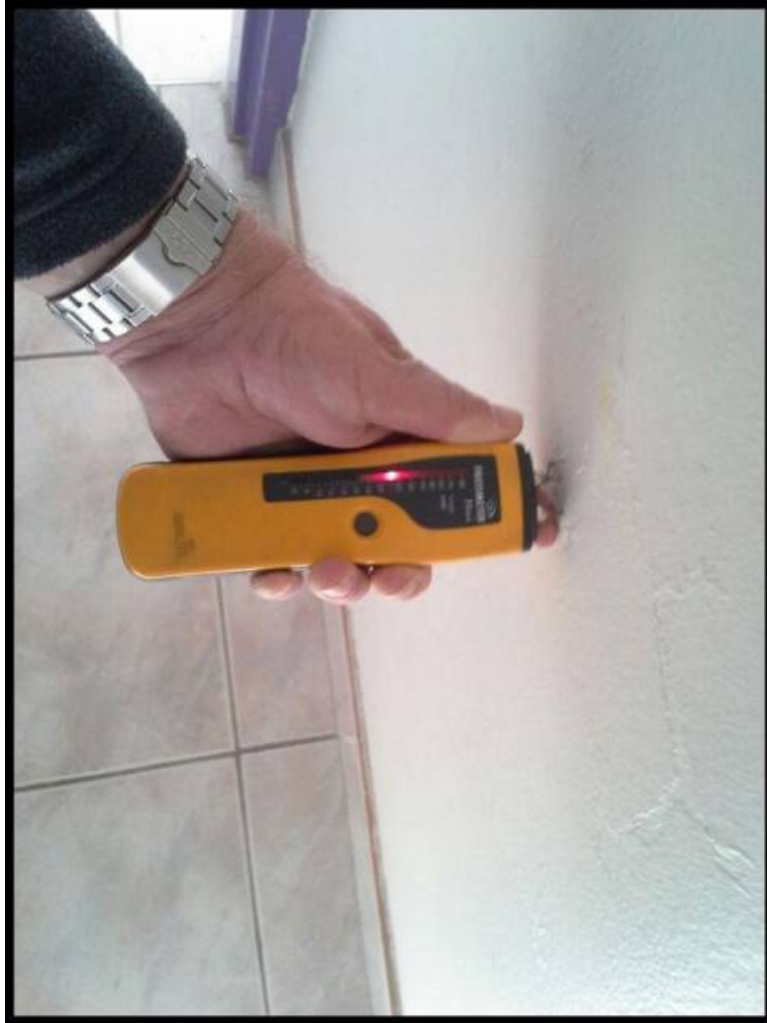
Bedroom two. Hallway.

Lateral dampness was detected in the wall backing onto the bathroom. This could be the result of a plumbing leak or leaking bathroom fixture and should be further investigated.

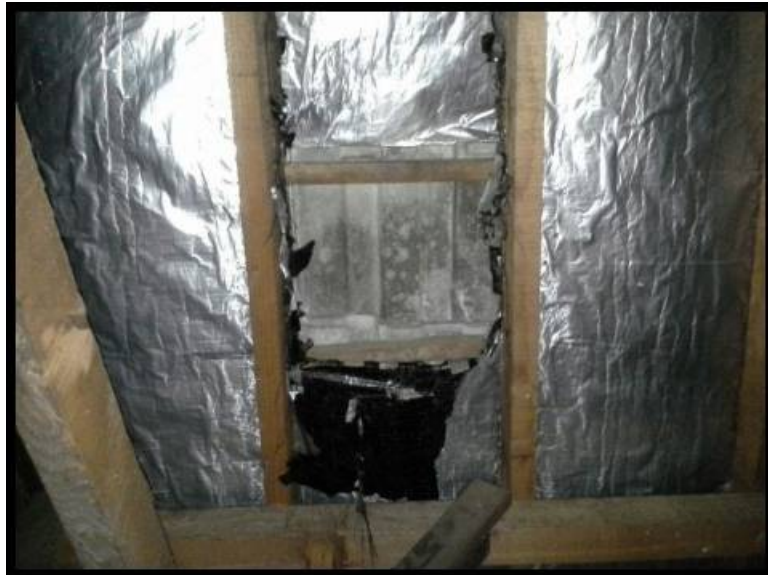
Sarking is present but is torn or has holes in some areas. This may affect the waterproofing ability of the sarking and damaged areas should be considered for repair.

Estimated cost from: \$350.
