Inspection reference: Sample Building Room by Room Report

# Confidential Inspection Report

1 Purchase Road  
Sydney NSW 2000

## VISUAL BUILDING INSPECTION REPORT

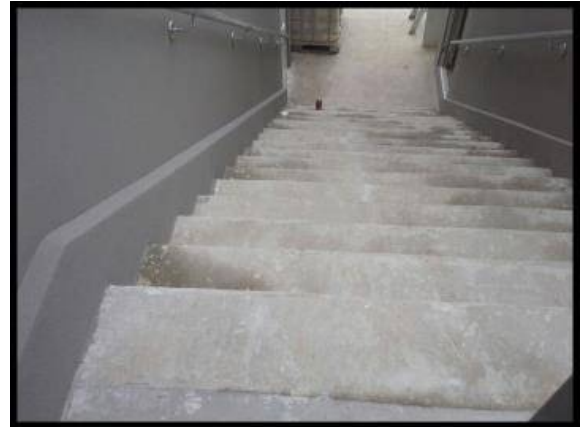
The stairs are constructed primarily from concrete. The condition of the stairs are generally acceptable. A full builders final clean including, cleaning, removal of trade marks, scuffs and touchup of paintwork is required to provide an acceptable finish to this area.

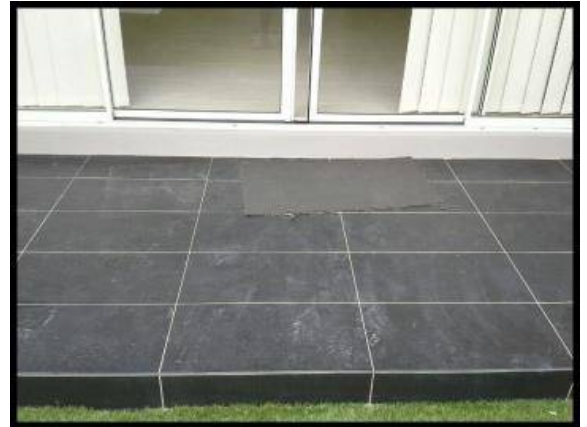
Marks and dirt are evident to the tiled areas. These areas will require cleaning. Rectification will be required. Minor paint touch required around door frame. Rectification will be required.

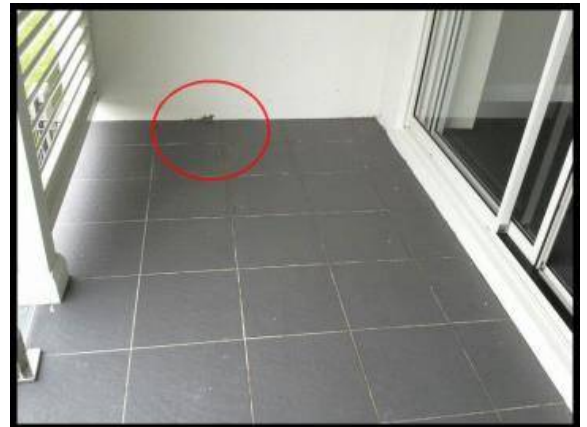
Note: Where timber is used in construction it is very important to ensure these timbers are well maintained and in sound condition. Timbers that are not regularly checked may develop timber decay damage or suffer timber pest attack and failure could cause injury or death.. The condition of the structure is generally acceptable. A full builders final clean including, cleaning, removal of trade marks, scuffs and touchup of paintwork is required to provide an acceptable finish to this area.

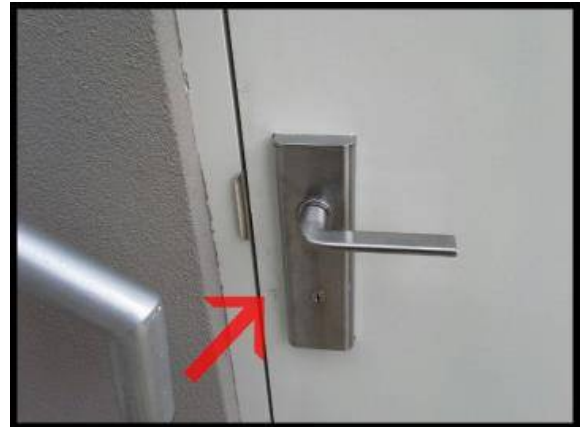
*Accommodation Type:* Garage.  
*Location:* To the rear of the main building.  
*General Condition:* The condition of the structure is generally acceptable.  
*External Door Condition:* Impact damage was noted to external door. Rectification will be required.

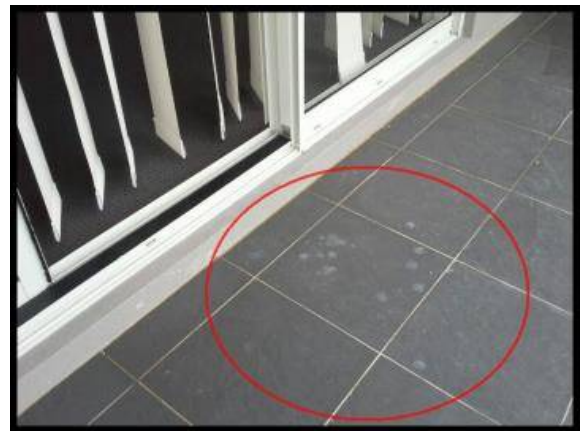
*Restrictions:* Floorcoverings were present and restricted inspection to the upperside of flooring. A full builders final clean including, vacuuming, cleaning, removal of skuffs and marks and touchup of paintwork is required to provide an acceptable finish to the internal and external area.

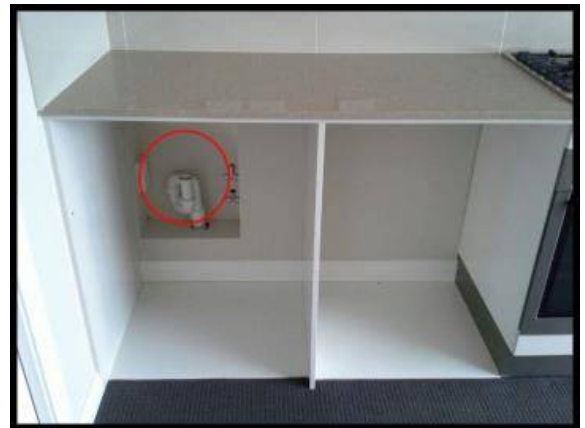
*Floor/Floor Waste:* There is no visible floor waste and no way for any overflow of water to escape. In the case of an overflow water may enter areas adjacent and cause a safety hazard or damage. Recommend a floor waste be installed or a fall be provided to the external of the building. Rectification will be required.

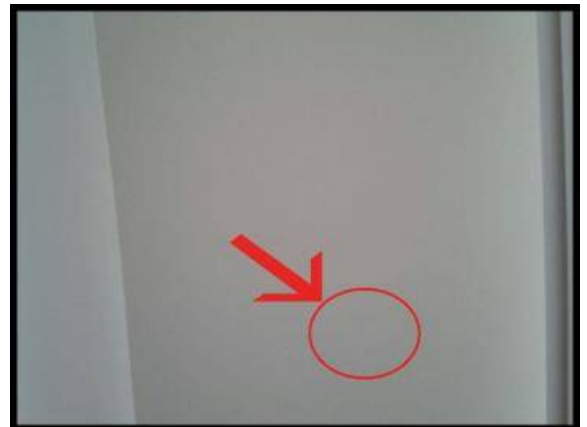
Painting is not complete, appears transparent and requires rectification to provide a suitable finish. Rectification will be required.

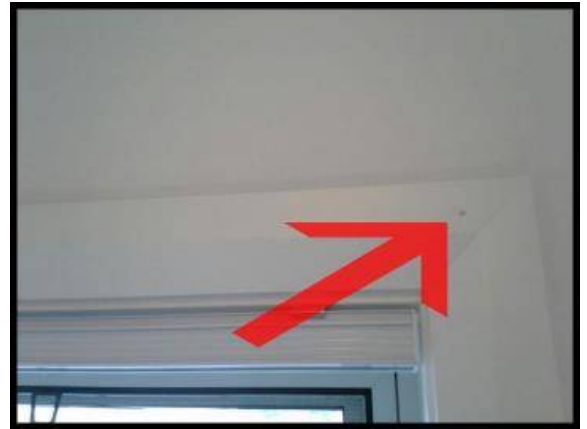
Minor damage noted requiring paint repair. Rectification will be required.

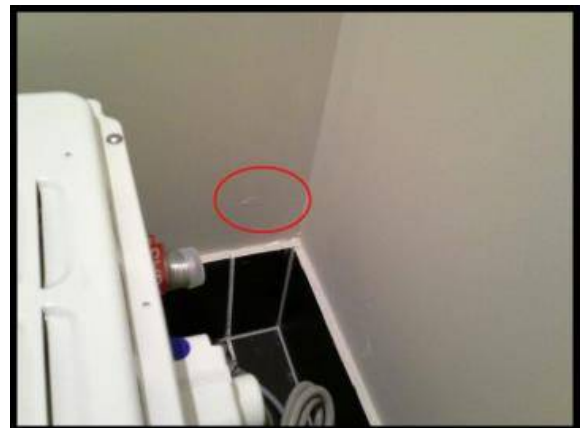
*Internal Walls Condition:* Poorly finished surfaces were noted to some sections of the wall materials and repairs are required prior to repainting. Rectification will be required.

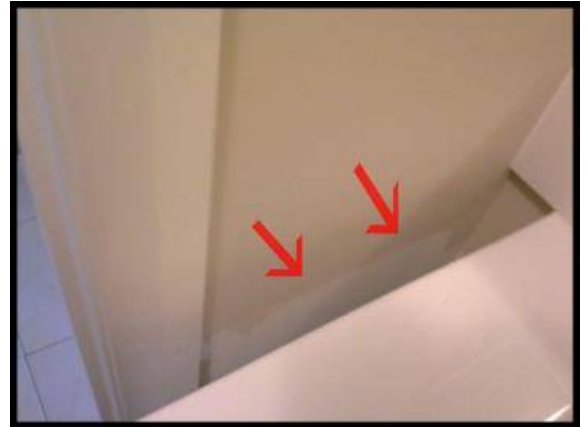
Painting to the vanity side wall is not complete, appears transparent and requires rectification to provide a suitable finish. Rectification will be required.

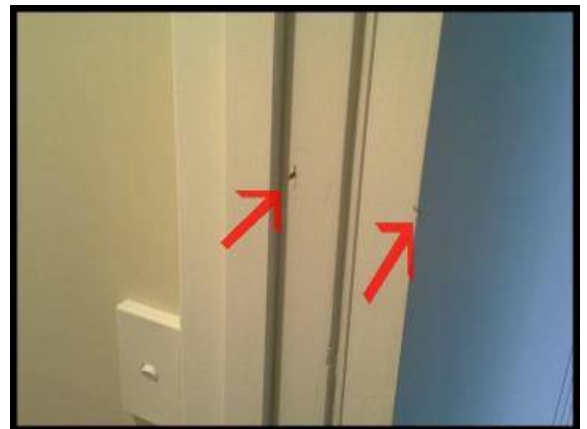
Door jamb/s are damaged and these areas will require maintenance, repair or replacement. Minor damage noted requiring paint repair. Rectification will be required.
