Inspection reference: Sample Dilapition Report

Confidential Inspection Report 8 Purchase Road Toowong QLD 4550

Report Type: Visual Dilapidation Building Inspection.

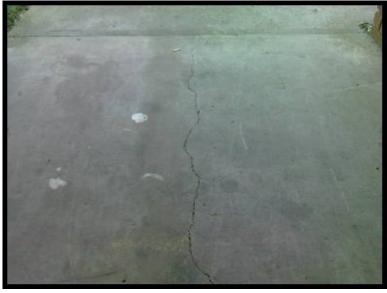
Appearance Defect Cracking: Crack Type: Patched Located: North elevation. Width: 4mm. Length: 3.0M.

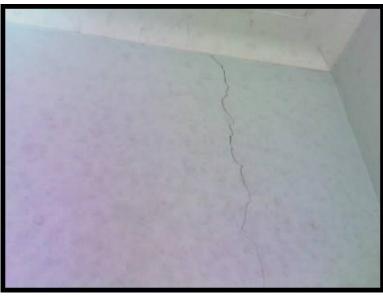
Serviceability Defect Cracking: Crack Type: Random crazing.

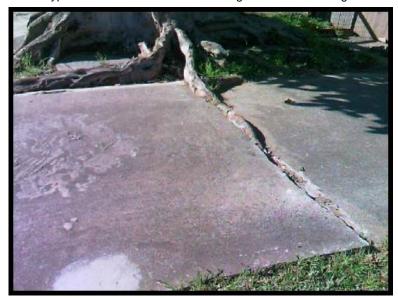
Structural Defect Cracking:

Crack Type: Differential movement cracking Width: 15mm Length: 3.0M.

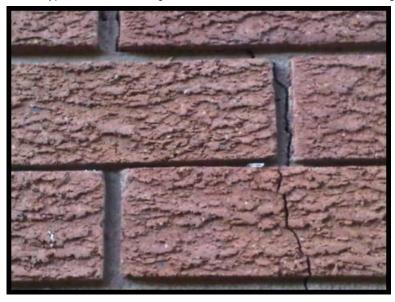
Structural Defect Cracking:

Crack Type: Hairline cracking Located: West elevation Width: 1mm Length: 1.8M.

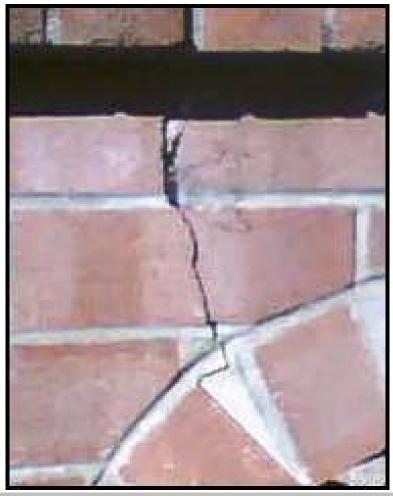
Appearance Defect Cracking: Crack Type: Stepped cracking Located: South elevation Width: 5mm. Length: 500mm.

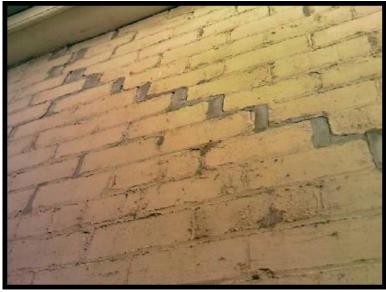
Structural Defect Cracking: Crack Type: Stepped cracking Located: North elevation Width: 10mm Length: 3.6M.

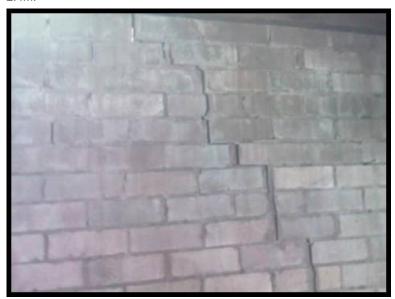
External Walls: Located to the sub floor rear of garage.

Noted Defect: Crack Type: Vertical cracking Located: North elevation Width: 3mm Length: 1.2M.

Crack Type: Vertical and stepped cracking Located: North elevation Width: 5mm Length: 2.4M.
