Confidential Inspection Report

Commissioned By: My Builder.
Contact: Joe.
Ref/File Number: 123:123.
Client: Will Buer.
Date Of Inspection: 28/10/2014.
Property Address: 5 Purchase Road Bathurst NSW 2886.

Inspection Type Practical Completion Report.
Inspector: Name: Dale Kennedy
Contact Number: 0425 223 008
Company: Alpha Building Services Pty Ltd
ABN: 47 103 963 471.

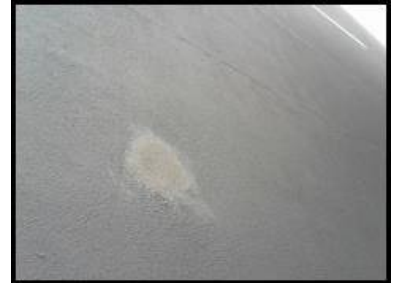
External Walls Mortar Cladding marks, poor finish, excess mortar, south elevation.

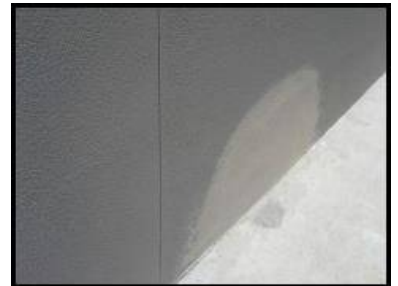
paint starved, south elevation.

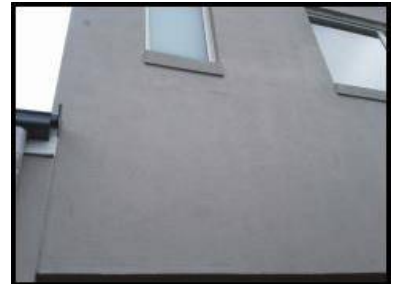
Mortar marks, poor finish, rear.

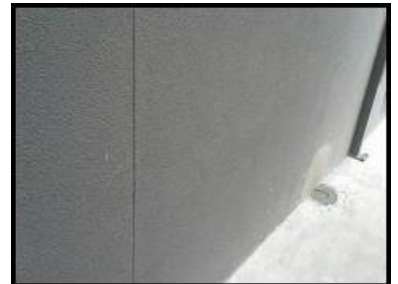
Mortar Cladding marks, dirty, paint starved, south elevation.

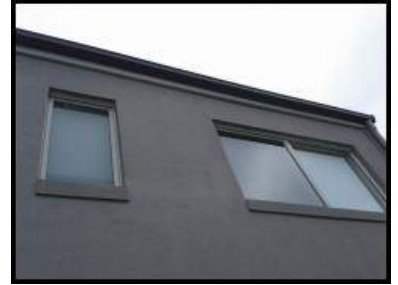
Reveal paint starved, Rear wall.

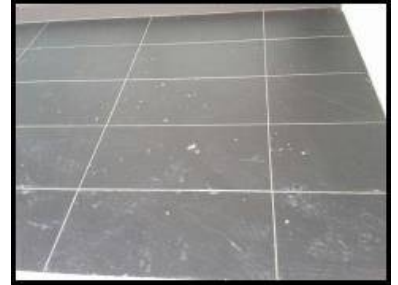
Floor tiles marks, dirty, over paint, outside of the Lounge.

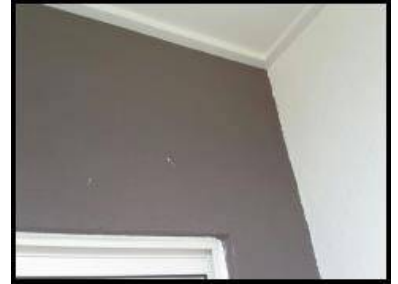
Mortar over paint, outside of the Lounge.

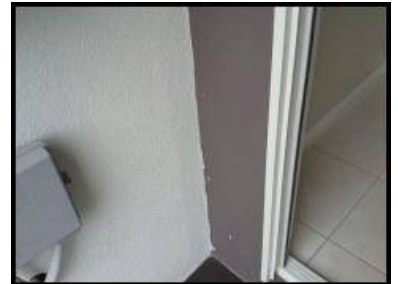
incomplete telstra service penetration, over paint, paint run, outside of the Entry.

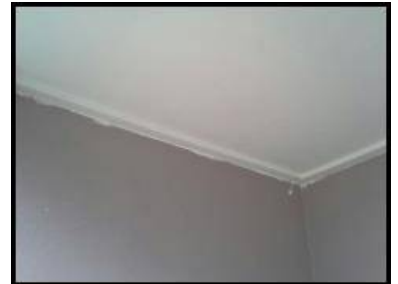
over paint, paint run, outside of the Dining room.

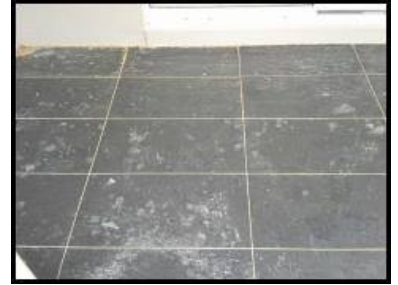
Floor tiles marks, dirty, outside of the Dining room.

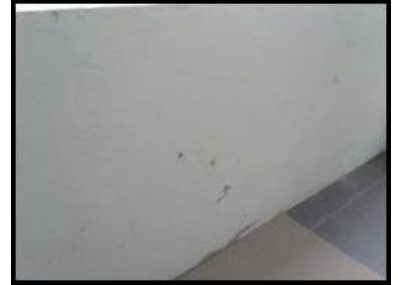
Cladding Floor tiles marks, dirty, paint starved, outside of the Bedroom two.

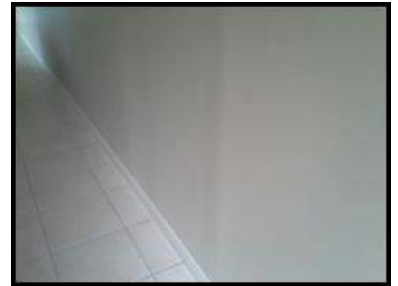
Poor plaster setting, visible joints. Right wall.

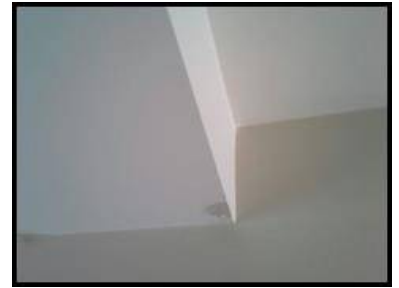
over paint, above right wall.

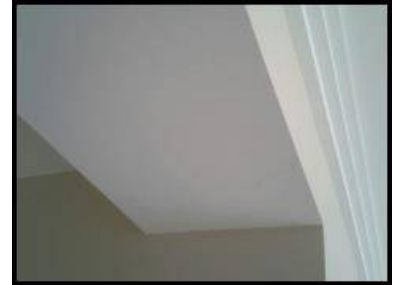
Ceiling marks, scratched, to left wall.

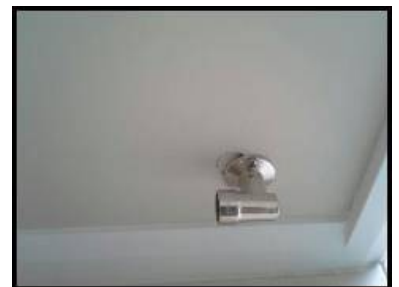
Bottom Impact damage, Rear wall.

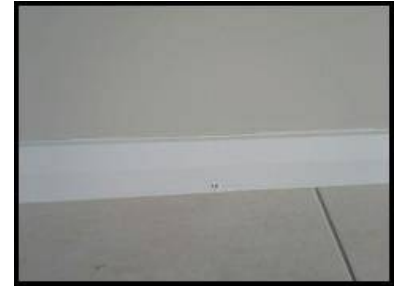
Skirting nail hole, left wall

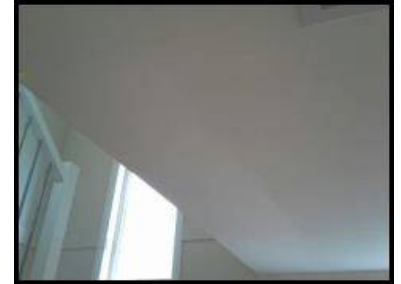
Ceiling paint starved, paint defect, generally.

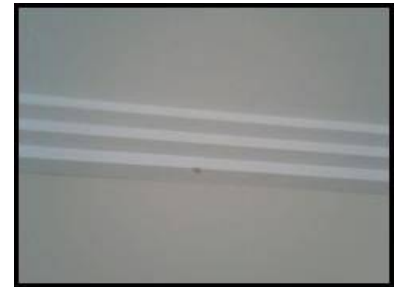
Cornice over paint, to rear wall.

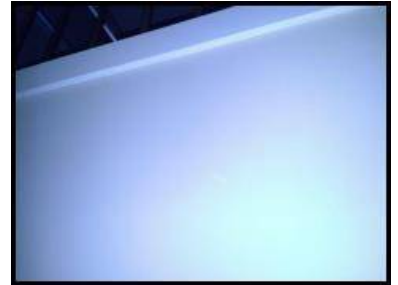
Scratched, Impact damage, Right wall.

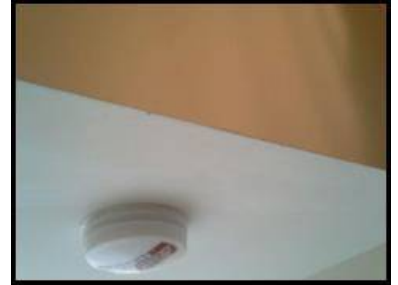
Ceiling scratched, paint starved.

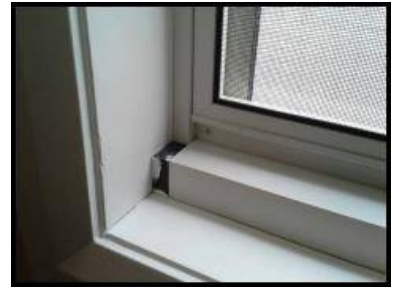
Reveal over paint, Right wall.

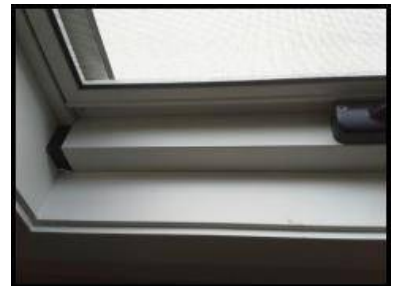
Reveal DAMAGE, impact damage, over paint, Right wall.

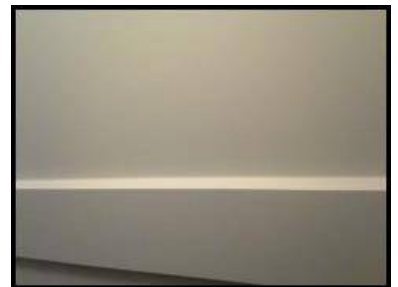
Skirting Impact damage, right wall

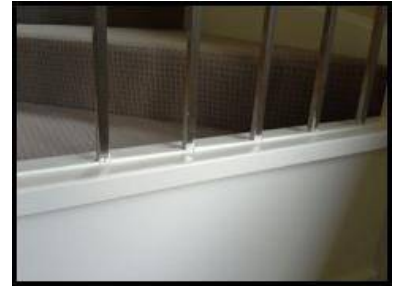
Stair string over paint, left wall
right wall

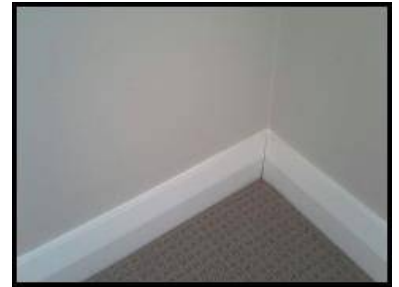
Skirting mitre poorly finished, front wall
right wall

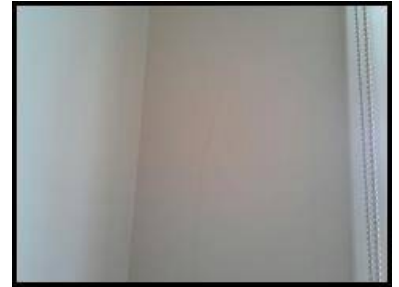
Marks, Scratched, Front wall, Right wall.

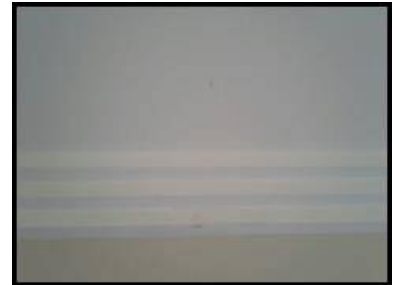
Ceiling Cornice marks, scratched, paint starved, to
left wall.

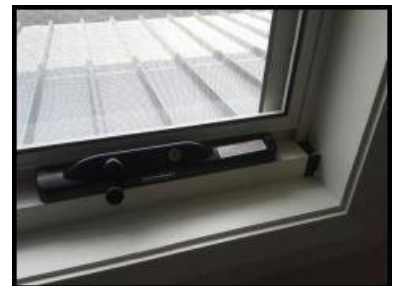
Reveal over paint, Front wall.

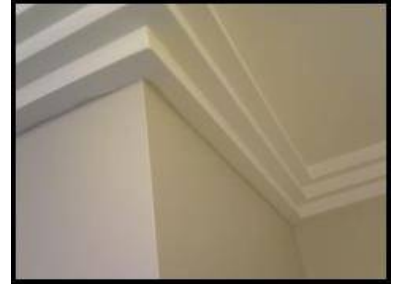
over paint, internal face, top.

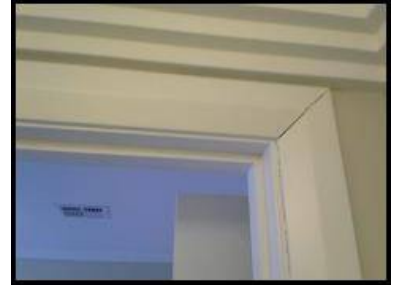
Architrave mitre poorly finished, beside door, robe.

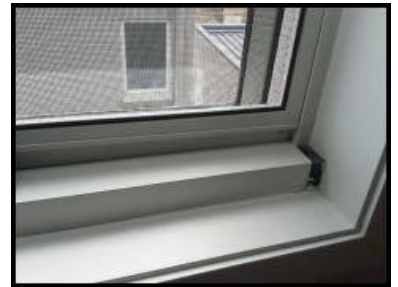
Reveal over paint, Left wall, Front wall.

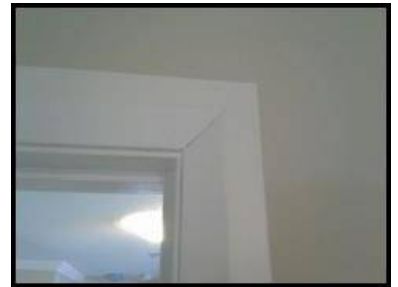
Architrave mitre poorly finished, right wall rear wall beside door.

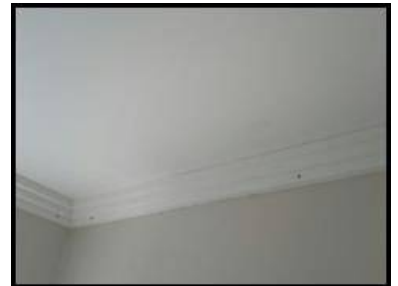
Ceiling Cornice incomplete, cracked, paint starved, hole/s, to right wall, near robe.

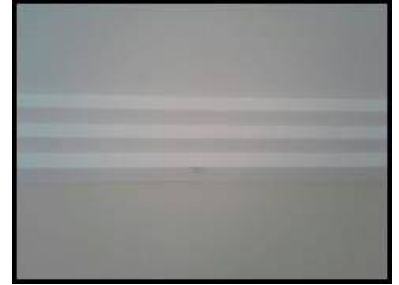
Cornice over paint, to right wall.

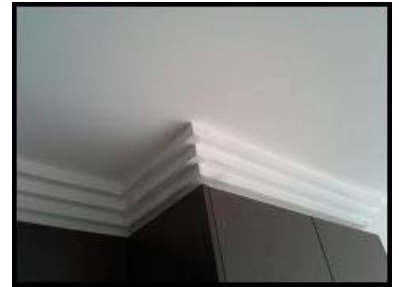
Ceiling Cornice paint starved, to left wall.

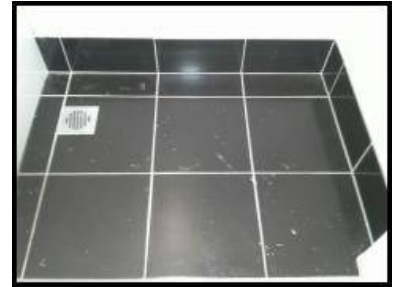
marks, dirty, over paint.

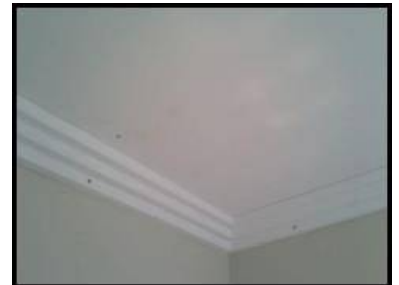
Ceiling Cornice incomplete, hole/s.

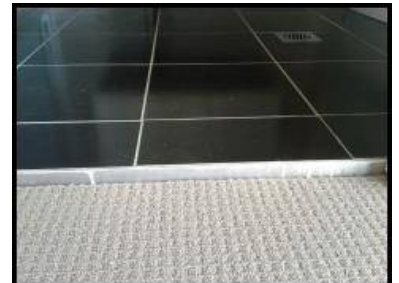
Floor Tile marks, dirty, paint run.

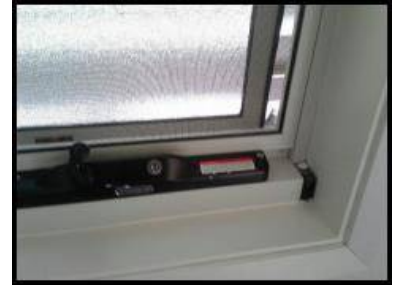
Reveal over paint.

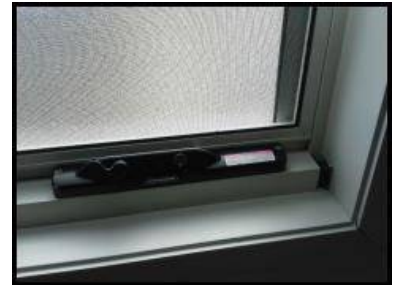
Reveal DAMAGE, over paint.

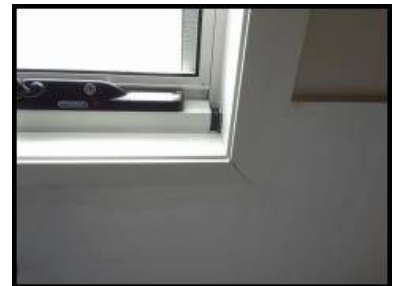
Architrave mitre poorly finished, window.

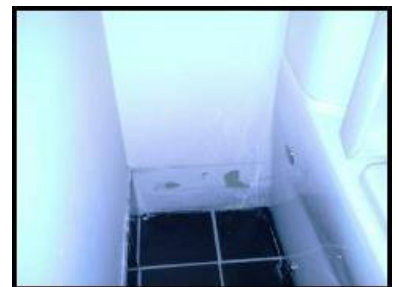
Tile/s DAMAGE, incomplete.

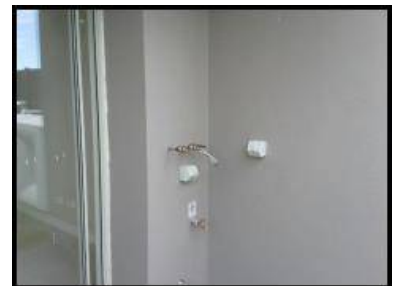
Unit is missing, Installation of the unit is not complete.
