Inspection reference: CR15072314

Confidential Inspection Report **1 Niger Place Kearns**

July 23, 2015

VISUAL TIMBER PEST INSPECTION REPORT

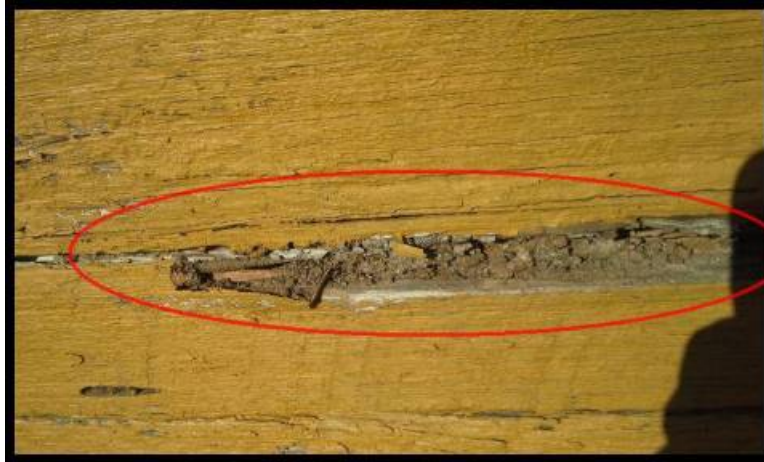
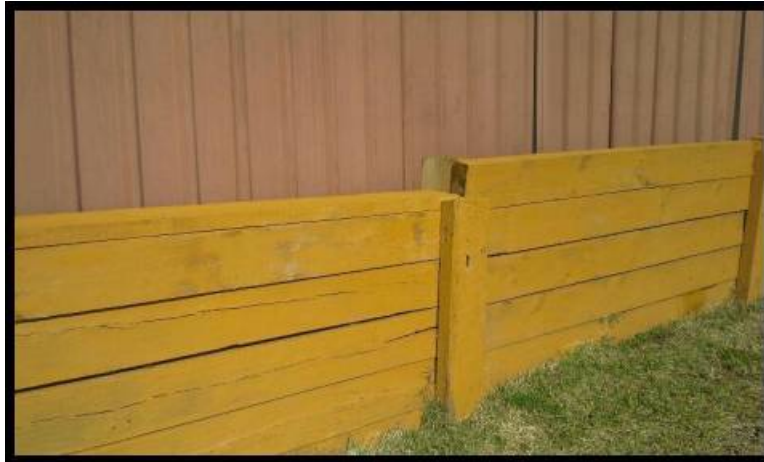
Sleepers or timber landscaping materials:

Damage Caused By Termites Found Yes - Inspection revealed currently inactive termite attack (damaged timbers and/or termite workings) within this area including but not necessarily limited to the following timbers and the areas listed below.

Visible timber damage appears moderate. Please refer to the building report for details or if a building inspection was not commissioned we recommend a builder inspection and report on the property. Refer to the definitions section of this report - TERMS & LIMITATIONS - Timber Damage.

Western elevation.

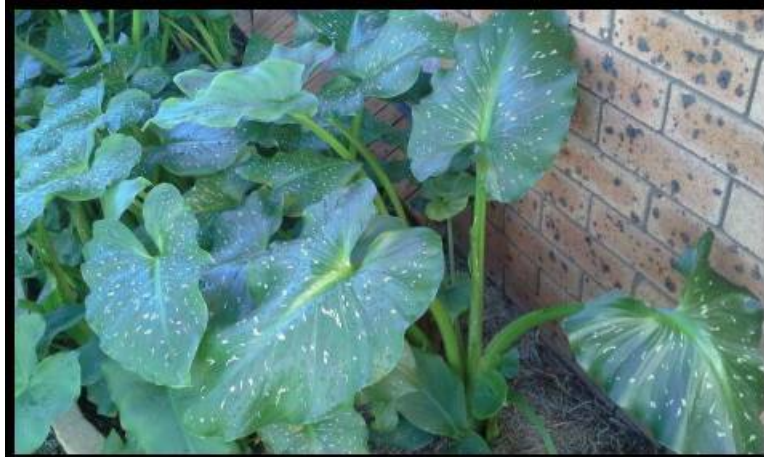
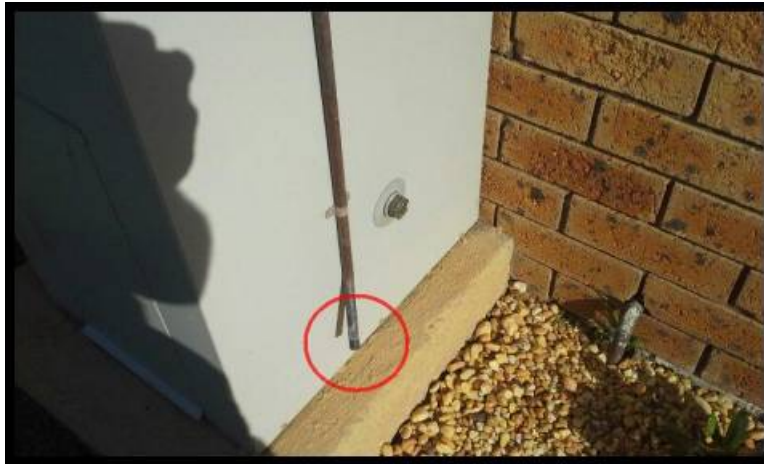
The air-conditioning condenser discharges adjacent to the external walls. We recommend modification so that water is discharged over a drain. We recommend the test drilling of trees or tree stumps on the property as they are capable of concealing termite colonies. The external vents/weep holes are either covered completely or partly concealed. This can allow concealed termite entry and we recommend that all vents/weep holes be exposed and kept clear of soil, foliage, debris, stored items or other obstructions. The level of some external paths, paved areas or soil is either higher than, or at a similar level, as that of the internal floors. This situation could allow concealed termite entry. We strongly recommend the lowering of these to below the internal floor

level to reduce the risk of concealed termite entry. The hot water system overflow is discharging moisture adjacent to the structure. We recommend the overflow be situated over a drain. Untreated landscaping timbers should be removed or replaced with a treated timber or non timber alternative. If replaced with timber, ensure appropriate durability rating for external use. Water is ponding on the soil adjacent to the building structure. This may be due to a drainage problem or some other factor. This should be rectified as moist soil conditions are highly conducive to timber pest attack. Garden beds have been built up against the external walls. These should be removed as they can allow concealed termite entry.

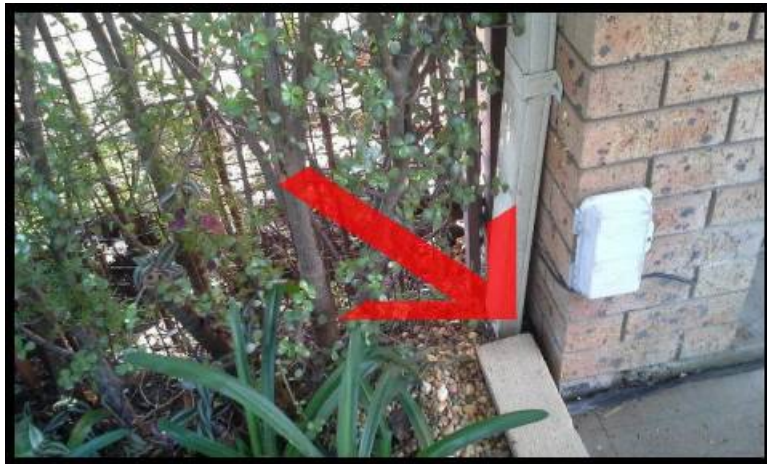
Garden beds have been built up against the external walls. These should be removed as they can allow concealed termite entry.

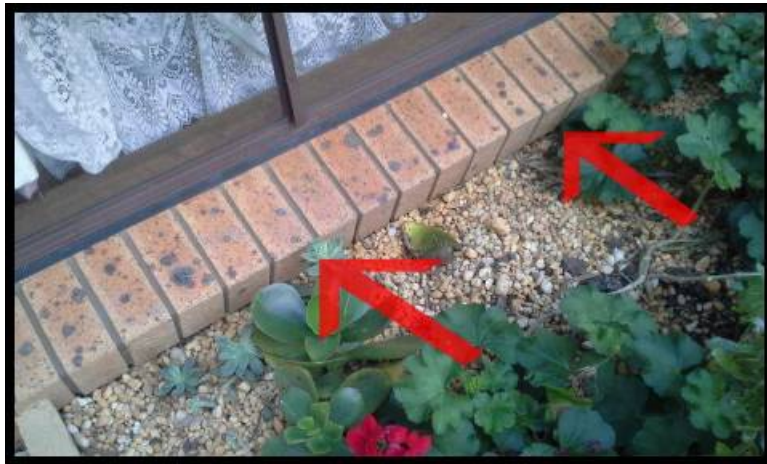
The property is constructed on a concrete slab foundation to which there is no subfloor for inspection. See important information in Section 4.0 Concrete Slab Homes (Part or Full Slab). Inspection of the concrete floor slab edge was restricted. In our experience, termites most commonly enter over the slab edge and therefore we recommend modifications be made by lowering all grounds levels to expose the concrete slab edge as this is an undetected entry point for timber pest attack, see Section 4.0 - Concrete Slab Homes (part or full). The following items restricted access to the edge of the slab; Soil. Paths. Patios. Gardens. Gravel. Brickwork. Timbers. Hot water service.

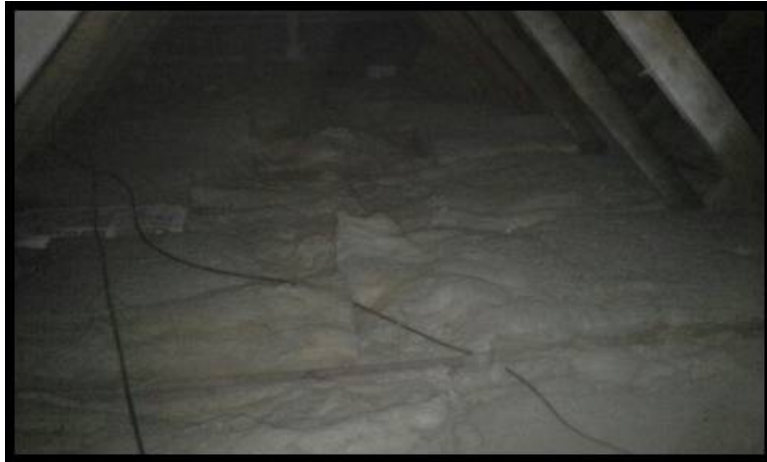
Insulation is present in the roof cavity. This restricted inspection to some roofing timbers. Removal of insulation is not within the scope of a standard visual inspection report.

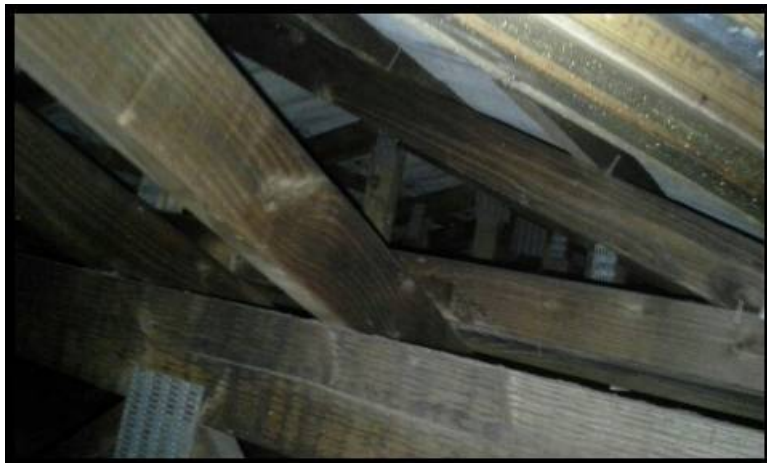
Inspection over the eaves was restricted due to the low pitch and construction allowing only a limited visual inspection. The roof is of trussed style construction and due to the nature of this construction inspection within the roof cavity was limited in some areas. Inspection was restricted above the following locations and or areas: Ensuite. Main bedroom. Entry/Foyer. Hallway.
